JAMES RIVER BASIN

Name of Dam: Sugar Hollow

Location: Albemarle County, State of Virginia

PHASE I INSPECTION REPORT NATIONAL DAM SAFETY PROGRAM

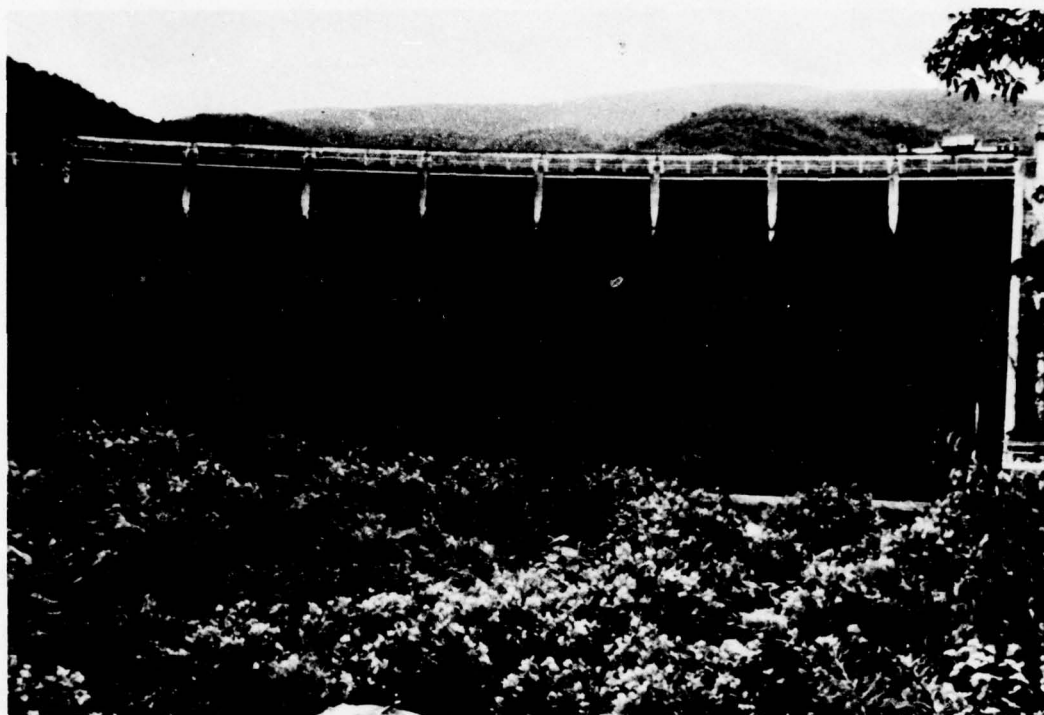
- 4.3 Maintenance of Operating Facilities: Maintenance personnel of the Rivanna Water and Sewer Authority operate the two slide gates for the 18 inch discharge pipes into the intake tower for the 24 inch water supply line. The spillway crest gates appear to be in good condition but they are not operated regularly.

PHOTO 1. View of Main Overflow Spillway Gate Hoist in Upper Right Corner

It was reported at the time of inspection and visually verified that the lift gates have not been operated for some time. It is recommended that regular operations of the lift gates' equipment be done to insure their working order.

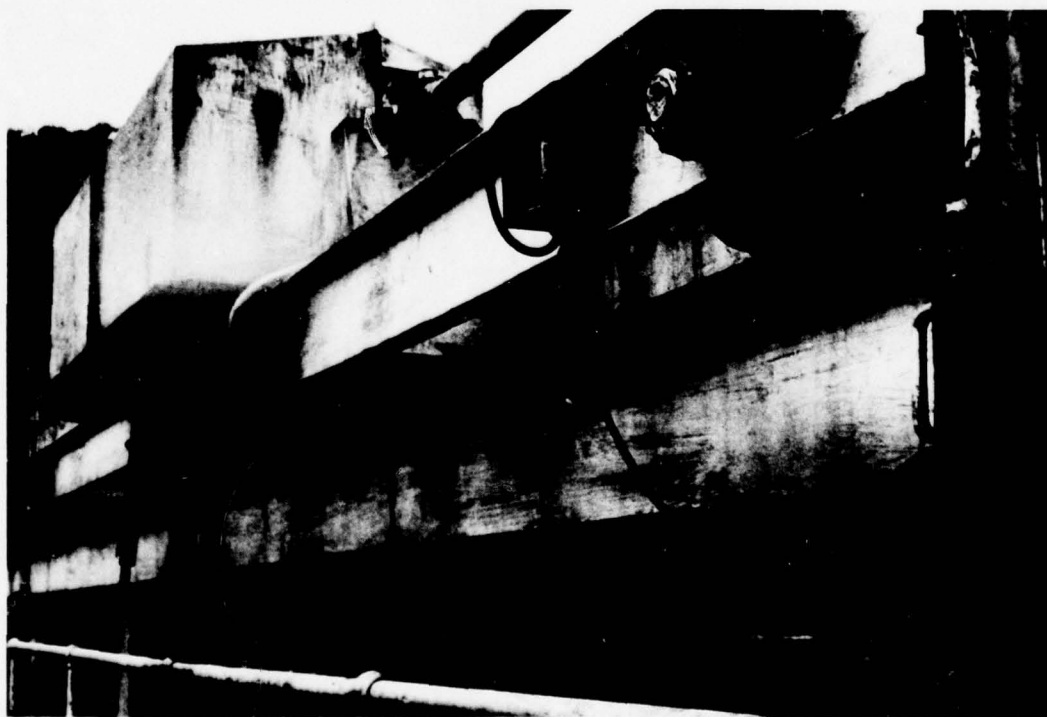
- 3.1.3 Appurtenant Structures: Some minor spalling and surface cracks were present on the intake tower and the walkway along the crest of the dam. Neoprene sealant had been "squeezed" out of the expansion joints along the crest; approximately one-fourth to one-half of an inch of expansion material is remaining. The crest gates were in good condition with no leakage present. It was reported during the time of inspection that the gates were not regularly operated. This was verified by the fact that the tracked gate hoist had a light coating of rust on the tracks and the hoist.

PHOTO 4. View of Gate Hoist

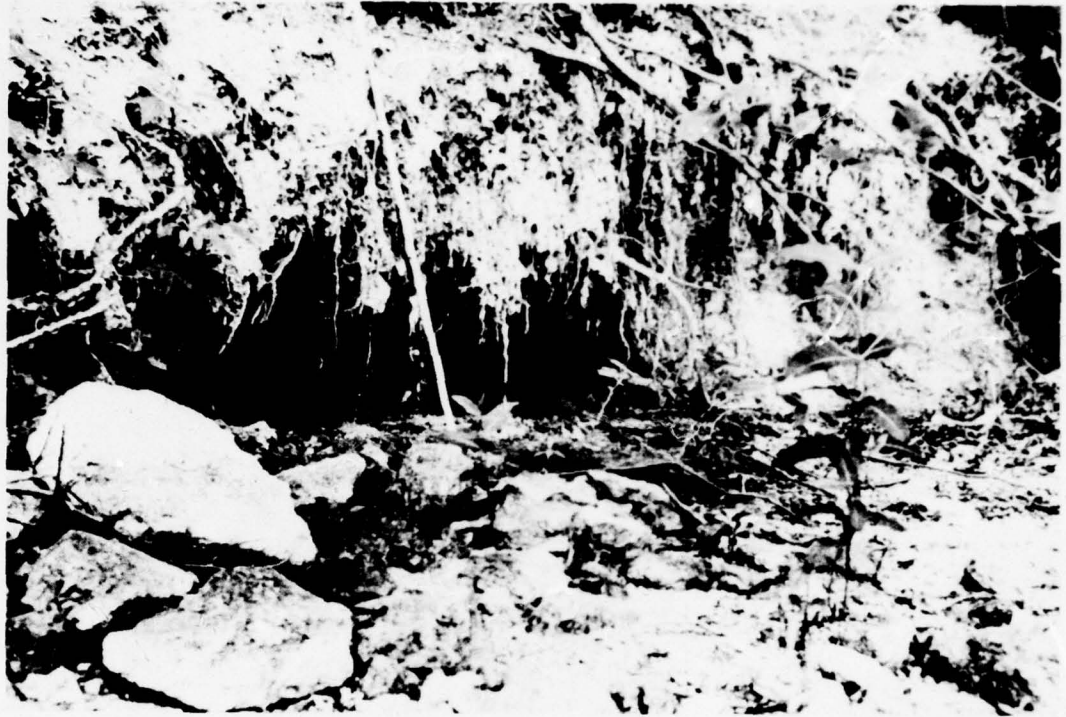
- 3.1.4 Reservoir Area: Evidence of erosion in the left abutment area upstream of the dam was observed at the time of inspection. No other areas of erosion were observed. Minor sedimentation of the reservoir was present in the upstream end.

PHOTO 7. Erosion of North Bank 100 Feet Upstream of Left Abutment

- 4) Check concrete in the intake dam of the stilling pool for progressive deterioration.
- 5) Annually operate the lift gates to assure proper functioning.
- 6) Repair erosion of the left upstream shoreline.
- 7) Divert surface runoff from the gallery entrance.
- 8) The operating condition of the valve in the 30 inch drawdown line should be determined.
